CREEP BEHAVIOR OF OXIDE/OXIDE COMPOSITES
WITH MONAZITE FIBER COATING
AT 1100 °C IN AIR AND IN STEAM ENVIRONMENTS

THESIS

AFIT/GA/ENY/08-S01

The creep behavior of six oxide-oxide ceramic-matrix composites (CMCs) was investigated at 1100 °C in laboratory air and in steam environments. The six CMC systems had an alumina (Al_2O_3) matrix reinforced with NextelTM610 fibers. The CMC systems C1, C2 and C3 were reinforced with 10 uni-directional fiber layers in a symmetric cross-ply (0°/90°/0°/90°/0°)_s orientation. In the case of composites C2 and C3, monazite (LaPO_4) fiber coating was applied to the fibers. Composite C1 contained no fiber coating. In the case of composites C1 and C2, alumina matrix was infiltrated with monazite. The CMC systems C4, C5, and C6 were reinforced with 8 plies of fiber fabric woven in a balanced eight-harness satin weave (8HSW). In the case of composites C4 and C6, monazite (LaPO_4) fiber coating was applied to the fibers. Composite C5 contained no fiber coating. In the case of composite C6, alumina matrix was infiltrated with AlOCl . The tensile stress-strain behaviors of the six CMC systems were investigated, and the tensile properties measured at 1100 °C

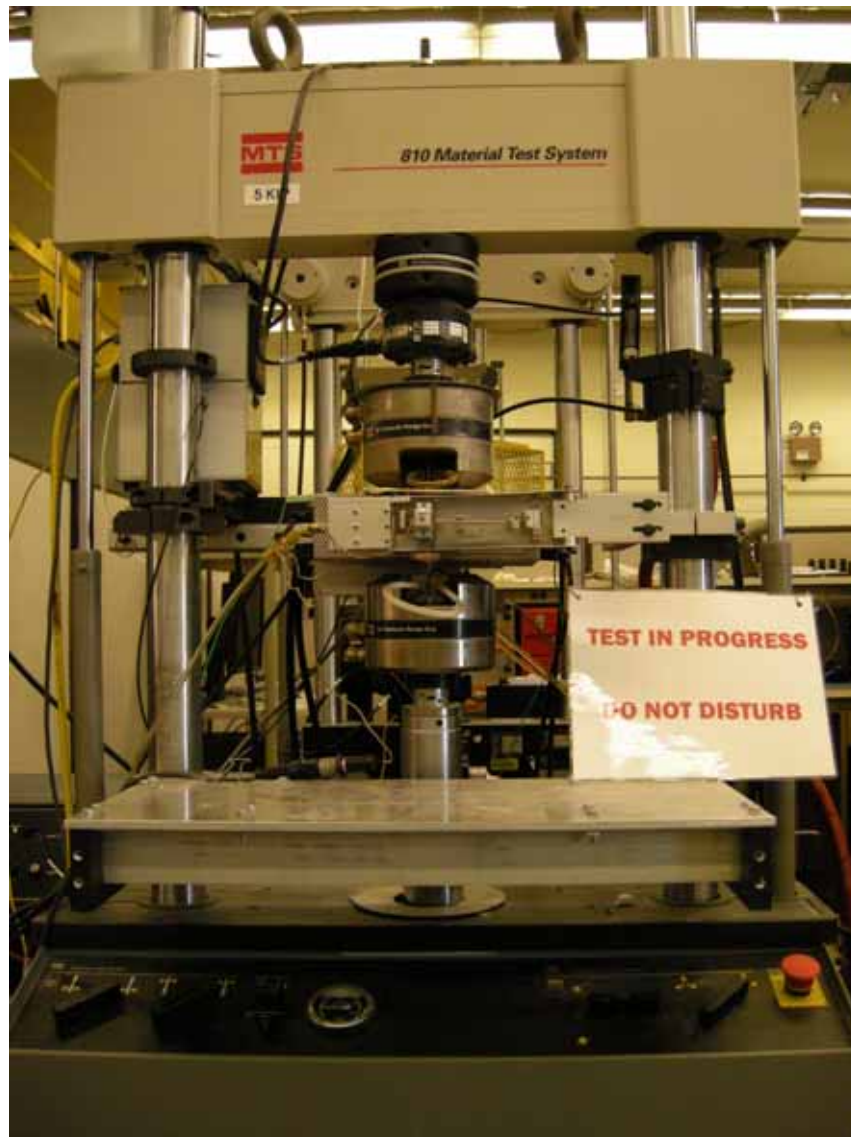
Figure 4.1: Mechanical testing station.

Mechanical testing was conducted on a MTS Systems Corporation model 810 Material Test System servo-hydraulic machine with the load capacity of 25 kN (5.5 kip). MTS Series 647 hydraulic wedge grips with a Surfalloy surfaces were used to grip the test specimen. A grip pressure in the 4-8 MPa range was used in all tests. Specific value of the grip pressure was selected based on the maximum load level expected in a particular test. The grips were water cooled with a Neslab model HX-75 chiller (shown in Fig. 4.2), which ensured that 15 °C cooling water was circulated through the grips during all tests. An MTS Test Star II controller was used for data acquisition and test control. MTS System Software and Multipurpose Testware (MPT) were used to program and execute the various tests. Fig. 4.1 shows the overall mechanical testing station set-up

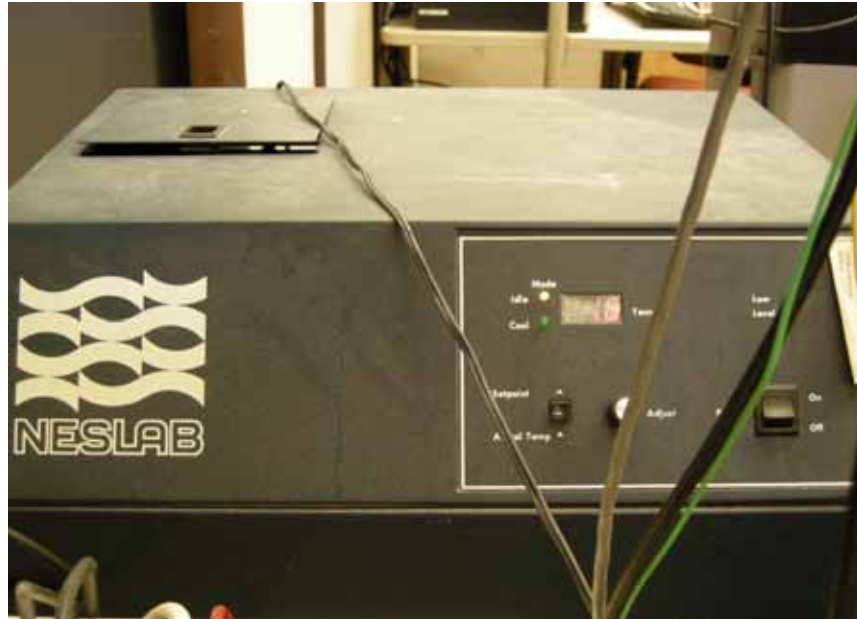
Figure 4.2: NESLAB model HX-75 chiller.

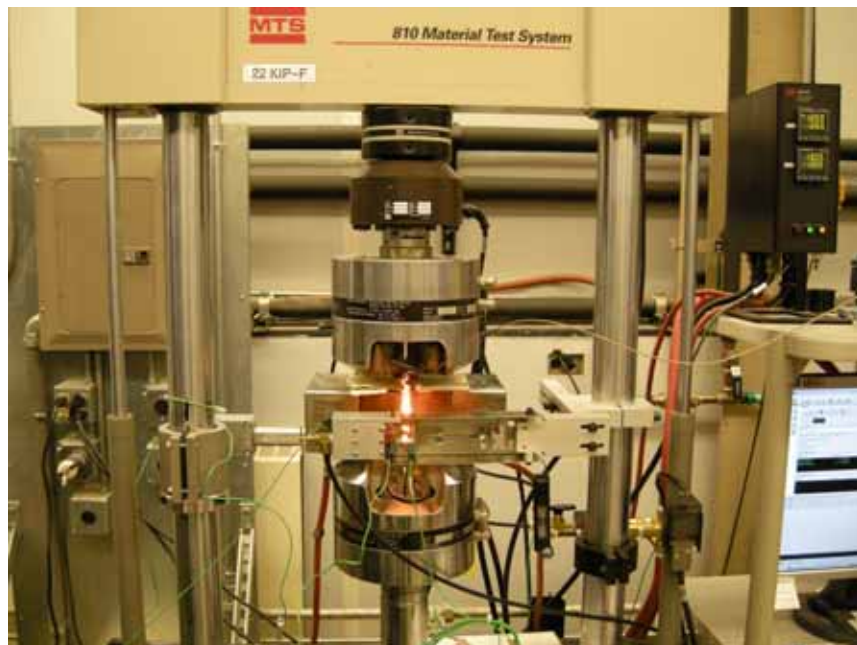
Figure 4.3: Close-up view of the MTS machine and the extensometer.

An MTS Force Transducer (Model 661.19E-04), with a 25 kN maximum capacity, was used for force measurement. Strain measurement was accomplished with a uniaxial, air-cooled, high-temperature, low contact force MTS Extensometer (Model 632.53E-14) with the 12.5 mm gage length. In all elevated temperature tests, the extensometer was equipped with 6-inch alumina contact rods and protected by a heat shield to maintain the unit temperatures within the manufacturers recommended range. Displacement measurement was accomplished with an LVDT internal to the MTS servo-hydraulic machine. Fig. 4.3 shows a close-up view of the MTS machine and the extensometer set-up.

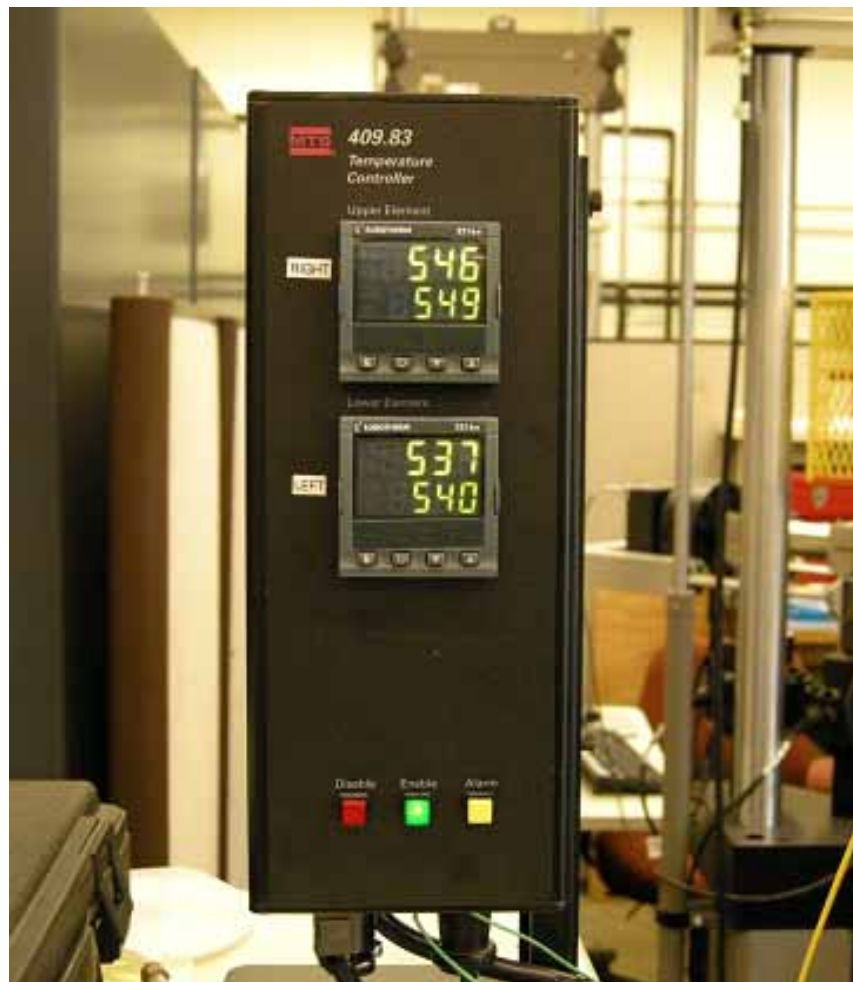
Figure 4.4: MTS Model 409.83B temperature controller.

ature controllers and a steam generator. A compact, two-zone AMTECO Hot-Rail Furnace System controlled by a MTS Model 409.83B temperature controller (shown in Fig. 4.4) was used in all tests. Each half of the furnace was fitted with a non-contacting R-type thermocouple, which provided temperature reading to the controller.

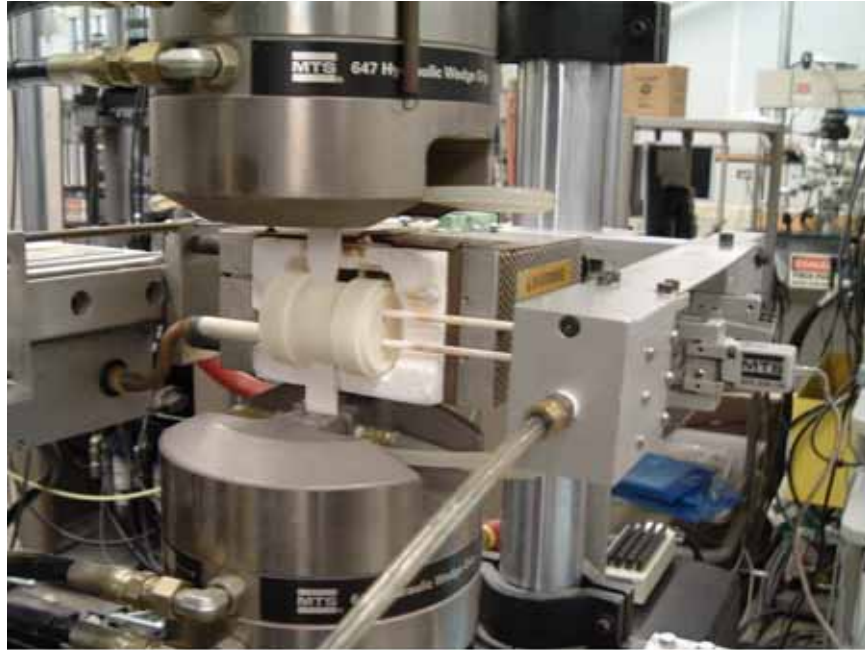
Figure 4.5: Susceptor assembly arrangement.

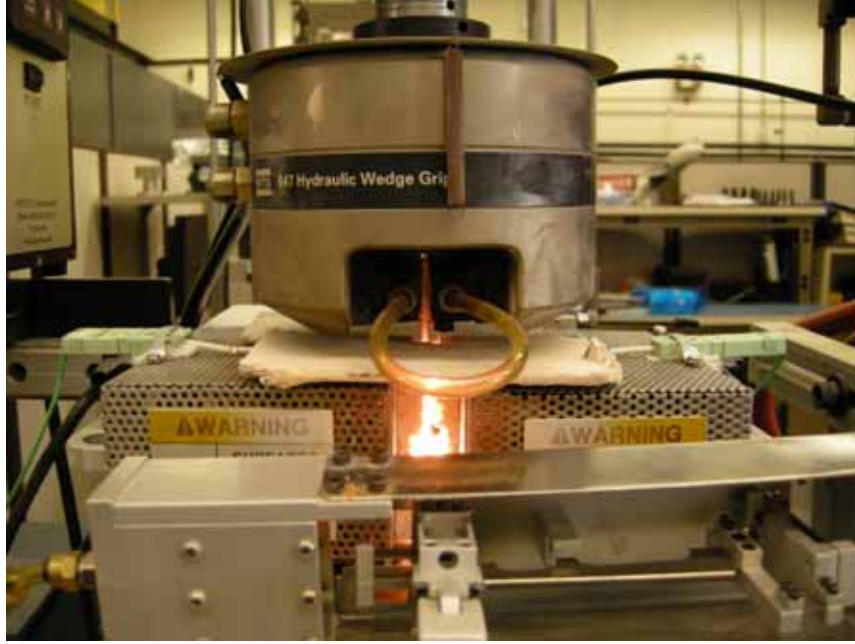
Figure 4.8: A typical test set-up.

Next, the specimen was placed in the grips. The top grip was closed while in displacement control and the load cell was auto-zeroed. Control was switched to force mode and the bottom grip was closed. For testing in steam, the susceptor was closed around the specimen and the oven was pulled forward into position making sure that the steam feeding tube was inserted into the opening in the back of the susceptor. The extensometer was mounted on the specimen. Then the oven was closed around the specimen and clearances for the extensometer rods were checked. The water chiller was turned on and the cooling water temperature set to 15 °C. The water lines for each grip were opened fully and the air cooling line for the extensometer was opened to 30 psi. A typical test set-up is shown in Fig. 4.8.

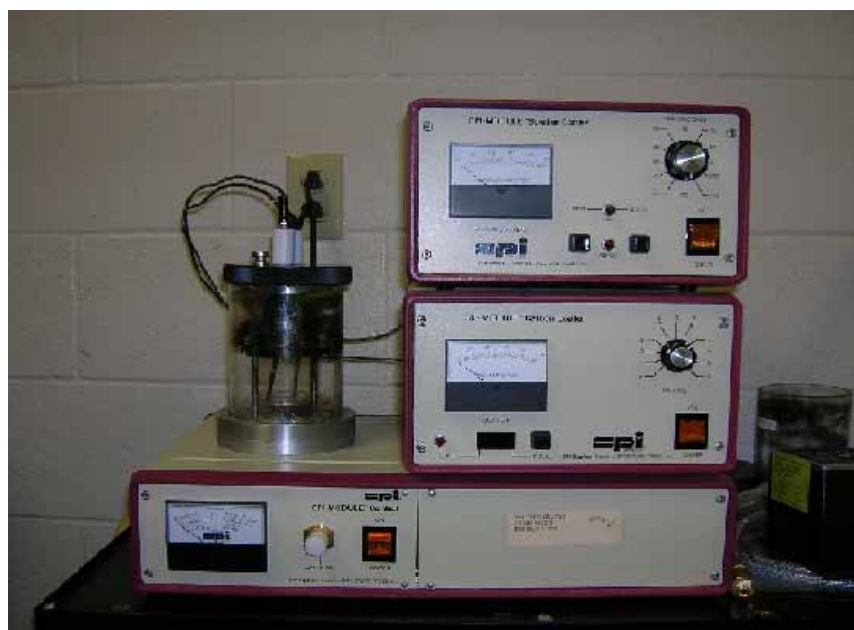
Figure 4.10: SPI-Module Controller and Carbon Coater.

Non-conductive materials like the alumina found in the six composites used in this study tend to build up a charge when bombarded by the electron beam of the SEM. This leads to distortion of the image and, if severe enough, can lead to damage of the specimen. To address this problem, SEM specimens were coated with a thin layer of a conductive material. Carbon coating was used in this research. An SPI Supplies SPI-Module Control and Carbon Coater, shown in Fig. 4.10, were used to coat the specimens.

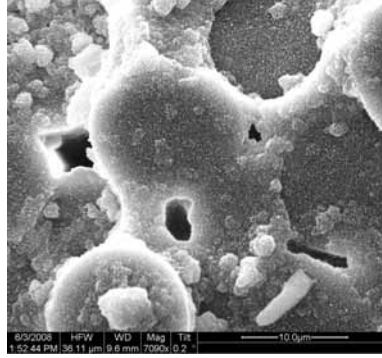
Figure A.6: Fracture surface of the N610/ Al_2O_3 - LaPO_4 specimen with 10ply $0^\circ/90^\circ$ uni-tape lay-up subjected to creep test at 32 MPa in steam at 1100 °C ($t_f = 3.45\text{h}$).

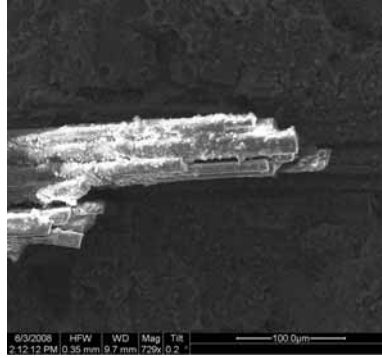
Figure A.10: Fracture surface of the N610/ Al_2O_3 - LaPO_4 specimen with 10ply $0^\circ/90^\circ$ uni-tape lay-up subjected to creep test at 32 MPa in steam at 1100 °C ($t_f = 3.45\text{h}$).

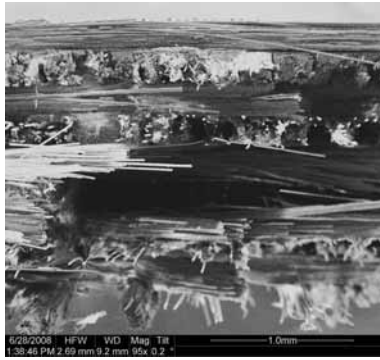
Figure A.43: Fracture surface of the N610/LaPO₄/Al₂O₃ specimen with 10ply 0°/90° uni-tape lay-up subjected to creep test at 85 MPa in air at 1100 °C ($t_f = 16.23\text{h}$).

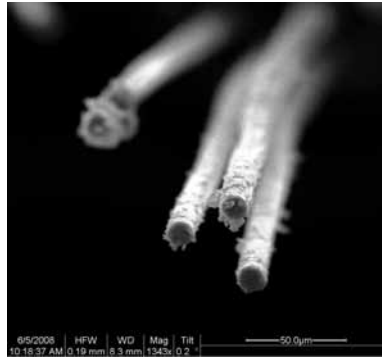
Figure A.70: Fracture surface of the N610/LaPO₄/Al₂O₃ specimen with 10ply 0°/90° uni-tape lay-up subjected to creep test at 120 MPa in steam at 1100 °C ($t_f = 0.0313h$).

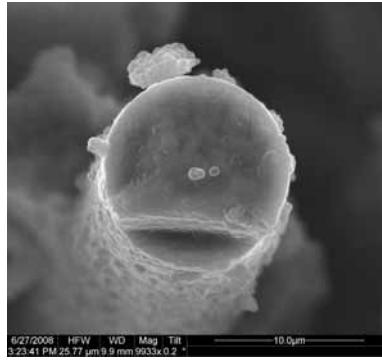
Figure A.82: Fracture surface of the N610/LaPO₄/Al₂O₃ specimen with 10ply 0°/90° uni-tape lay-up subjected to creep test at 120 MPa in air at 1100 °C ($t_f = 0.748\text{h}$).

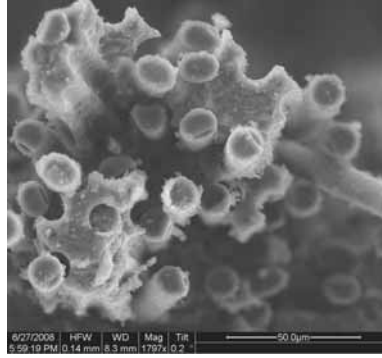
Figure A.87: Fracture surface of the N610/LaPO₄/Al₂O₃ specimen with 10ply 0°/90° uni-tape lay-up subjected to creep test at 120 MPa in air at 1100 °C ($t_f = 0.748\text{h}$).

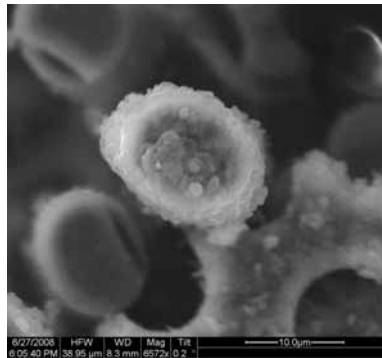
Figure A.89: Fracture surface of the N610/LaPO₄/Al₂O₃ specimen with 10ply 0°/90° uni-tape lay-up subjected to creep test at 120 MPa in air at 1100 °C ($t_f = 0.748\text{h}$).

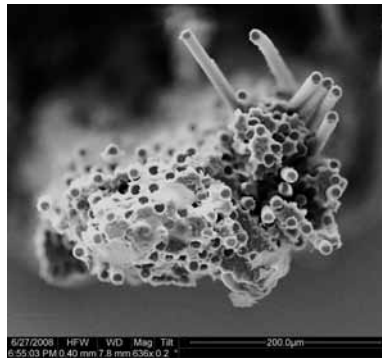
Figure A.101: Fracture surface of the N610/LaPO₄/Al₂O₃ specimen with 10ply 0°/90° uni-tape lay-up subjected to creep test at 120 MPa in air at 1100 °C ($t_f = 0.748h$).

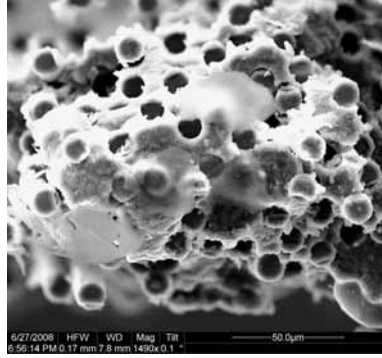
Figure A.102: Fracture surface of the N610/LaPO₄/Al₂O₃ specimen with 10ply 0°/90° uni-tape lay-up subjected to creep test at 120 MPa in air at 1100 °C ($t_f = 0.748\text{h}$).

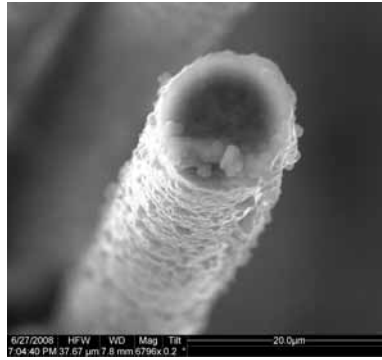
Figure A.106: Fracture surface of the N610/LaPO₄/Al₂O₃ specimen with 10ply 0°/90° uni-tape lay-up subjected to creep test at 120 MPa in air at 1100 °C ($t_f = 0.748\text{h}$).

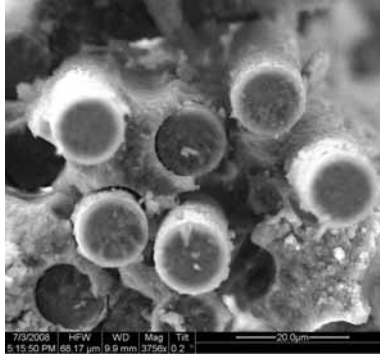
Figure A.132: Fracture surface of the N610/LaPO₄/Al₂O₃ specimen with 10ply 0°/90° uni-tape lay-up subjected to creep test at 85 MPa in steam at 1100 °C ($t_f = 8.183\text{h}$).

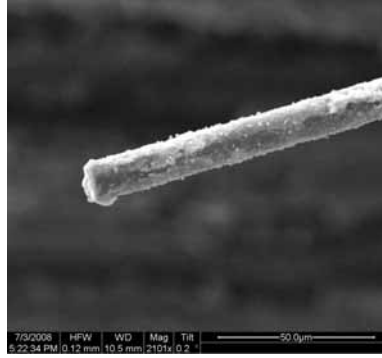
Figure A.135: Fracture surface of the N610/LaPO₄/Al₂O₃ specimen with 10ply 0°/90° uni-tape lay-up subjected to creep test at 85 MPa in steam at 1100 °C ($t_f = 8.183\text{h}$).

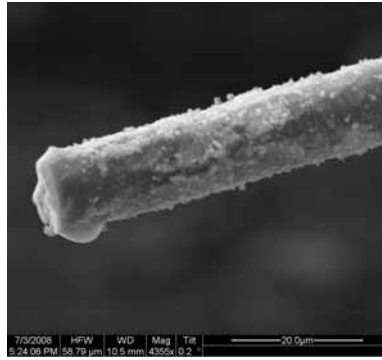
Figure A.136: Fracture surface of the N610/LaPO₄/Al₂O₃ specimen with 10ply 0°/90° uni-tape lay-up subjected to creep test at 85 MPa in steam at 1100 °C ($t_f = 8.183\text{h}$).

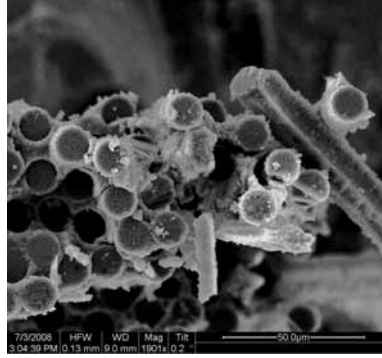
Figure A.144: Fracture surface of the N610/LaPO₄/Al₂O₃ specimen with 8ply HSW subjected to creep test at 32 MPa in air at 1100 °C ($t_f = 100h$).

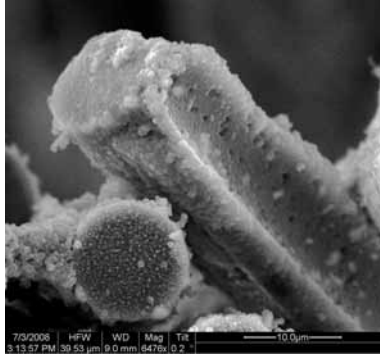
Figure A.147: Fracture surface of the N610/LaPO₄/Al₂O₃ specimen with 8ply HSW subjected to creep test at 32 MPa in air at 1100 °C ($t_f = 100\text{h}$).

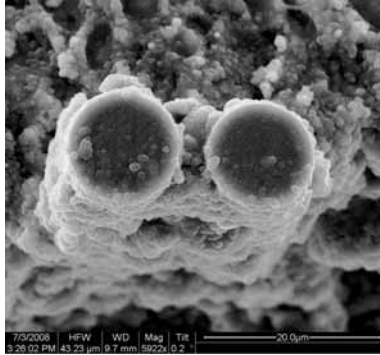
Figure A.151: Fracture surface of the N610/LaPO₄/Al₂O₃ specimen with 8ply HSW subjected to creep test at 32 MPa in air at 1100 °C ($t_f = 100\text{h}$).

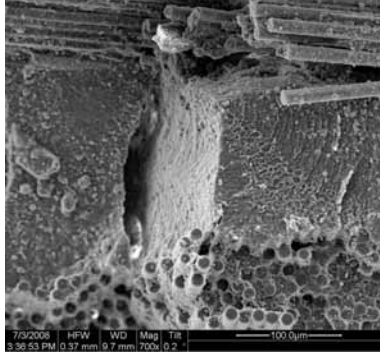
Figure A.157: Fracture surface of the N610/LaPO₄/Al₂O₃ specimen with 8ply HSW subjected to creep test at 32 MPa in air at 1100 °C ($t_f = 100\text{h}$).

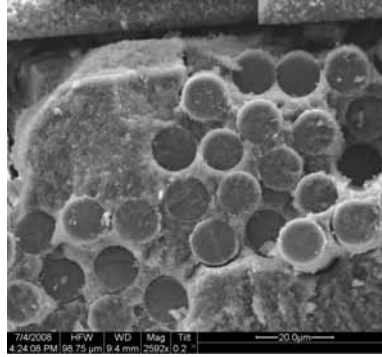
Figure A.202: Fracture surface of the N610/LaPO₄/Al₂O₃ specimen with 8ply HSW subjected to creep test at 72 MPa in air at 1100 °C ($t_f = 100h$).

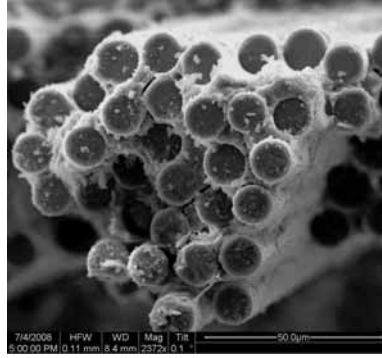
Figure A.219: Fracture surface of the N610/LaPO₄/Al₂O₃ specimen with 8ply HSW subjected to creep test at 72 MPa in air at 1100 °C ($t_f = 100\text{h}$).

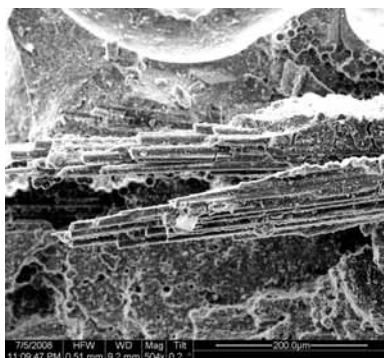
Figure A.266: Fracture surface of the N610/ Al_2O_3 specimen with 8ply HSW subjected to creep test at 30 MPa in steam at 1100 °C ($t_f = 16.1\text{h}$).

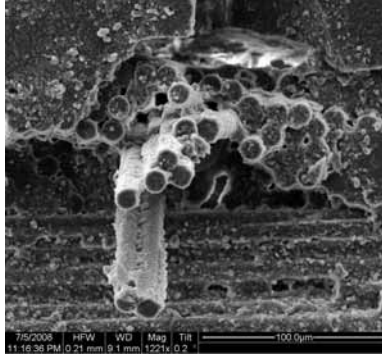
Figure A.270: Fracture surface of the N610/ Al_2O_3 specimen with 8ply HSW subjected to creep test at 30 MPa in steam at 1100 °C ($t_f = 16.1\text{h}$).

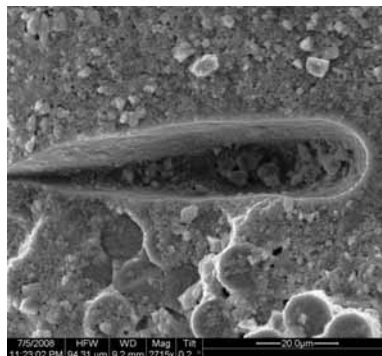
Figure A.275: Fracture surface of the N610/ Al_2O_3 specimen with 8ply HSW subjected to creep test at 30 MPa in steam at 1100 °C ($t_f = 16.1\text{h}$).

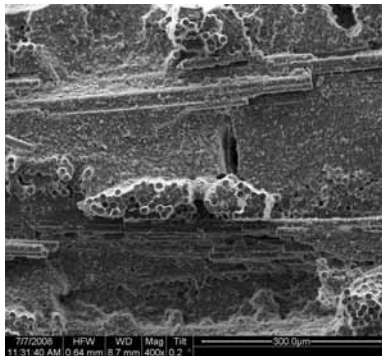
Figure A.293: Fracture surface of the N610/ Al_2O_3 specimen with 8ply HSW subjected to creep test at 40.5 MPa in air at 1100 °C ($t_f = 3.34\text{h}$).

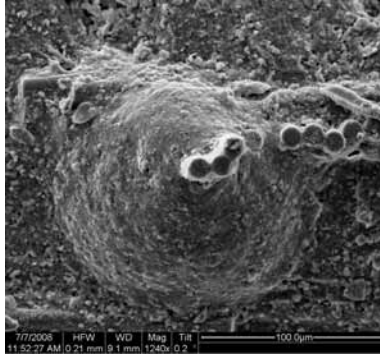
Figure A.304: Fracture surface of the N610/Al₂O₃ specimen with 8ply HSW subjected to creep test at 40.5 MPa in air at 1100 °C ($t_f = 3.34h$).

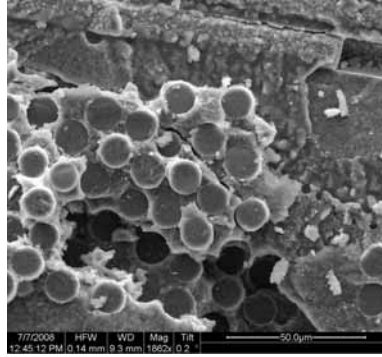
Figure A.370: Fracture surface of the N610/LaPO₄/Al₂O₃-LaPO₄-AlOCl specimen with 8ply HSW subjected to creep test at 32 MPa in air at 1100 °C ($t_f = 100\text{h}$).

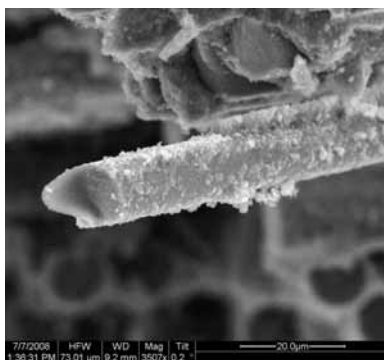
Figure A.396: Fracture surface of the N610/LaPO₄/Al₂O₃-LaPO₄-AlOCl specimen with 8ply HSW subjected to creep test at 32 MPa in air at 1100 °C ($t_f = 100\text{h}$).

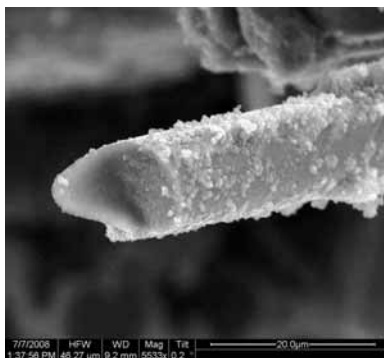
Figure A.397: Fracture surface of the N610/LaPO₄/Al₂O₃-LaPO₄-AlOCl specimen with 8ply HSW subjected to creep test at 32 MPa in air at 1100 °C ($t_f = 100\text{h}$).

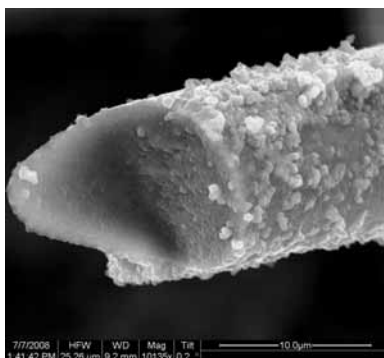
Figure A.398: Fracture surface of the N610/LaPO₄/Al₂O₃-LaPO₄-AlOCl specimen with 8ply HSW subjected to creep test at 32 MPa in air at 1100 °C ($t_f = 100\text{h}$).

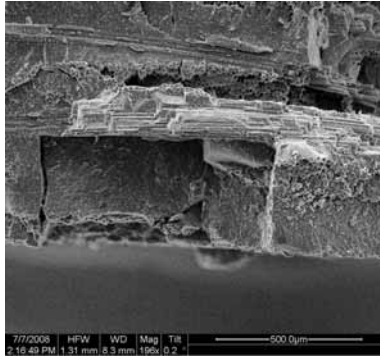
Figure A.402: Fracture surface of the N610/LaPO₄/Al₂O₃-LaPO₄-AlOCl specimen with 8ply HSW subjected to creep test at 32 MPa in steam at 1100 °C ($t_f = 3.47\text{h}$).

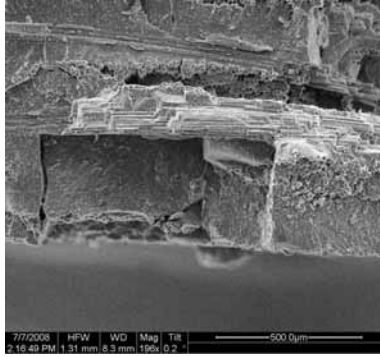
Figure A.403: Fracture surface of the N610/LaPO₄/Al₂O₃-LaPO₄-AlOCl specimen with 8ply HSW subjected to creep test at 32 MPa in steam at 1100 °C ($t_f = 3.47\text{h}$).

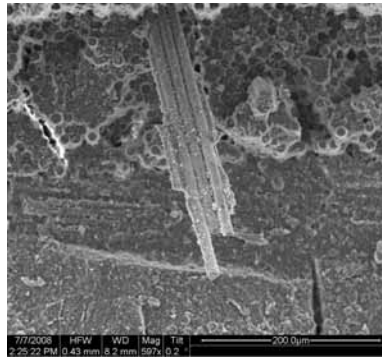
Figure A.409: Fracture surface of the N610/LaPO₄/Al₂O₃-LaPO₄-AlOCl specimen with 8ply HSW subjected to creep test at 32 MPa in steam at 1100 °C ($t_f = 3.47\text{h}$).

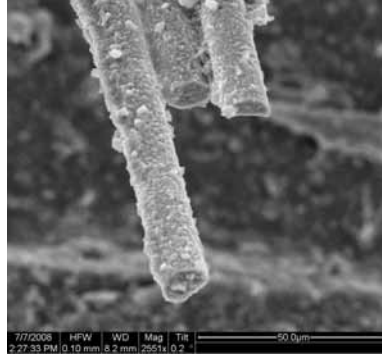
Figure A.411: Fracture surface of the N610/LaPO₄/Al₂O₃-LaPO₄-AlOCl specimen with 8ply HSW subjected to creep test at 32 MPa in steam at 1100 °C ($t_f = 3.47\text{h}$).

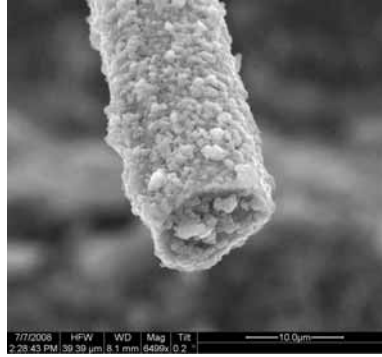
Figure A.412: Fracture surface of the N610/LaPO₄/Al₂O₃-LaPO₄-AlOCl specimen with 8ply HSW subjected to creep test at 32 MPa in steam at 1100 °C ($t_f = 3.47\text{h}$).

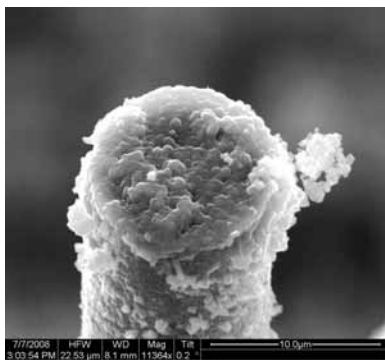
Figure A.436: Fracture surface of the N610/LaPO₄/Al₂O₃-LaPO₄-AlOCl specimen with 8ply HSW subjected to creep test at 32 MPa in steam at 1100 °C ($t_f = 3.47\text{h}$).

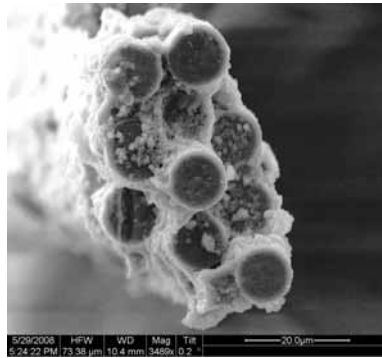
Figure A.445: Fracture surface of the N610/LaPO₄/Al₂O₃-LaPO₄-AlOCl specimen with 8ply HSW subjected to creep test at 48 MPa in steam at 1100 °C ($t_f = 2.06\text{h}$).

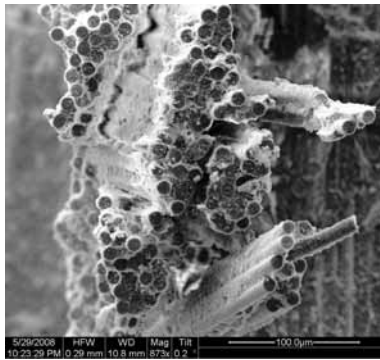
Figure A.463: Fracture surface of the N610/LaPO₄/Al₂O₃-LaPO₄-AlOCl specimen with 8ply HSW subjected to creep test at 48 MPa in steam at 1100 °C ($t_f = 2.06\text{h}$).

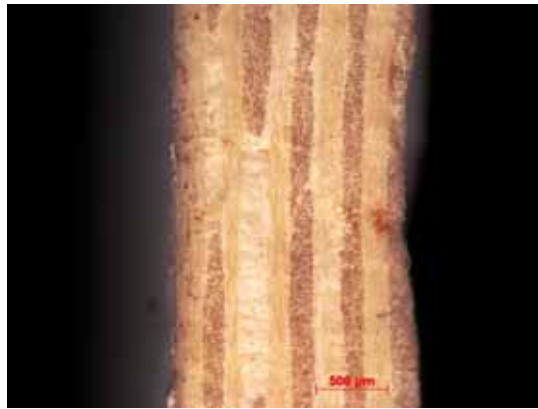
Figure B.4: Side view of the virgin N610/ Al_2O_3 - LaPO_4 specimen with 10ply $0^\circ/90^\circ$ uni-tape lay-up.

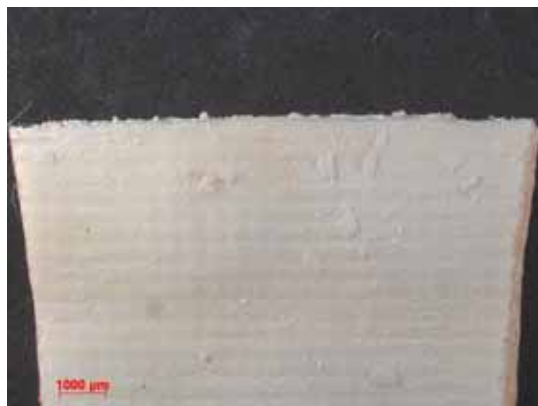
Figure B.5: Fracture surface of the N610/ Al_2O_3 - LaPO_4 specimen with 10ply $0^\circ/90^\circ$ uni-tape lay-up subjected tension to failure in laboratory air at 1100°C .

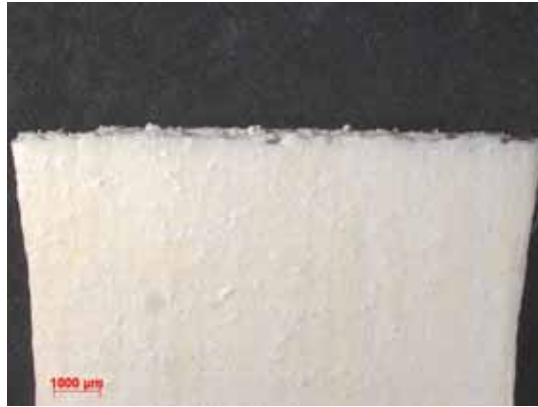
Figure B.6: Fracture surface of the N610/ Al_2O_3 - LaPO_4 specimen with 10ply $0^\circ/90^\circ$ uni-tape lay-up subjected tension to failure in laboratory air at 1100 °C.

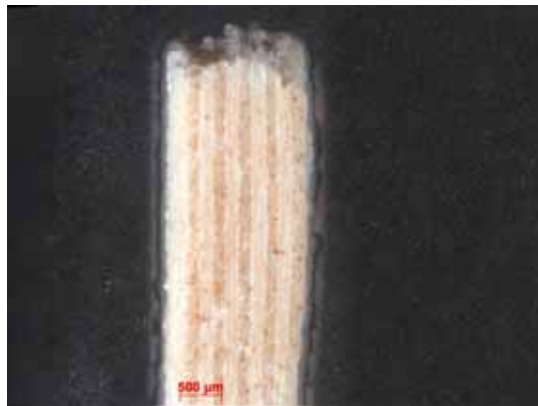
Figure B.8: Fracture surface of the N610/ Al_2O_3 - LaPO_4 specimen with 10ply $0^\circ/90^\circ$ uni-tape lay-up subjected tension to failure in laboratory air at 1100 °C.

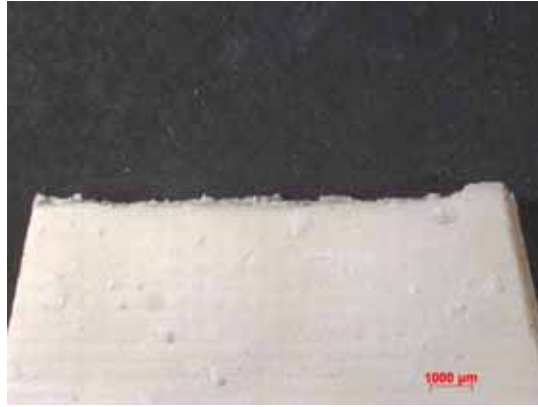
Figure B.9: Fracture surface of the N610/ Al_2O_3 - LaPO_4 specimen with 10ply $0^\circ/90^\circ$ uni-tape lay-up subjected tension to failure in laboratory air at 1100 °C.

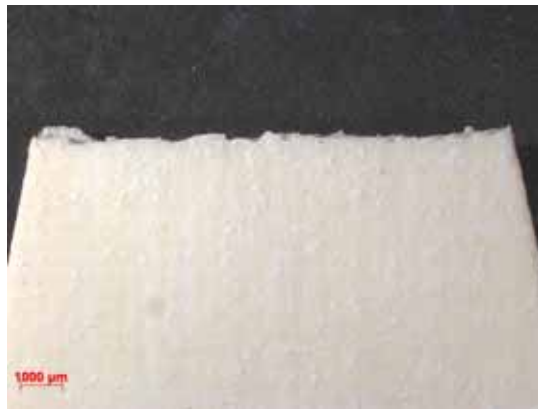
Figure B.10: Fracture surface of the N610/ Al_2O_3 - LaPO_4 specimen with 10ply $0^\circ/90^\circ$ uni-tape lay-up subjected tension to failure in laboratory air at 1100 °C.

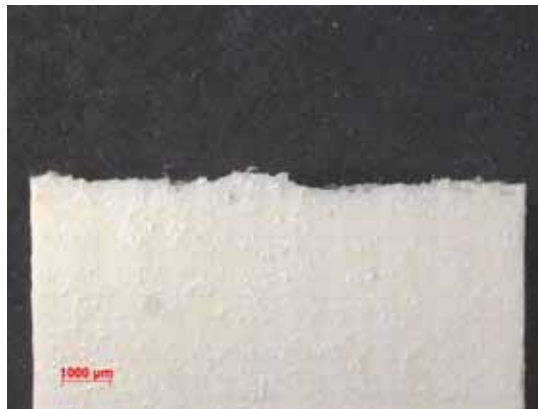
Figure B.13: Fracture surface of the N610/Al₂O₃-LaPO₄ specimen with 10ply 0°/90° uni-tape lay-up subjected to creep test at 32 MPa in steam at 1100 °C ($t_f = 3.45$ h).

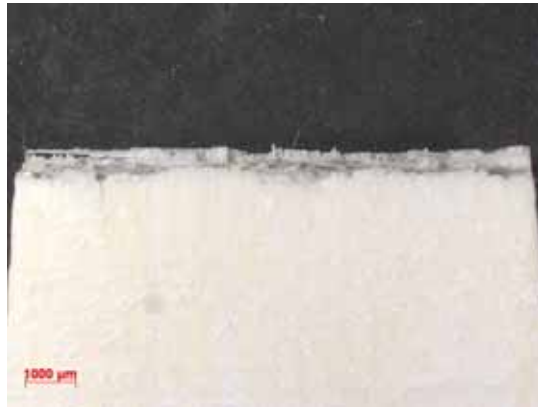
Figure B.16: Fracture surface of the N610/ Al_2O_3 - LaPO_4 specimen with 10ply $0^\circ/90^\circ$ uni-tape lay-up subjected to creep test at 32 MPa in steam at 1100 °C ($t_f = 3.45$ h).

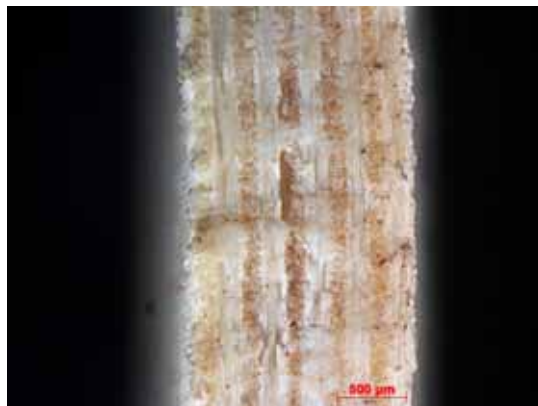
Figure B.19: Side view of the virgin N610/ LaPO_4 / Al_2O_3 - LaPO_4 specimen with 10ply $0^\circ/90^\circ$ uni-tape lay-up.

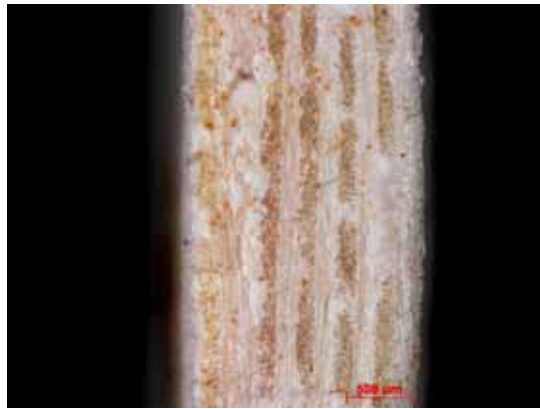
Figure B.24: Side view of the virgin N610/LaPO₄/Al₂O₃-LaPO₄ specimen with 10ply 0°/90° uni-tape lay-up.

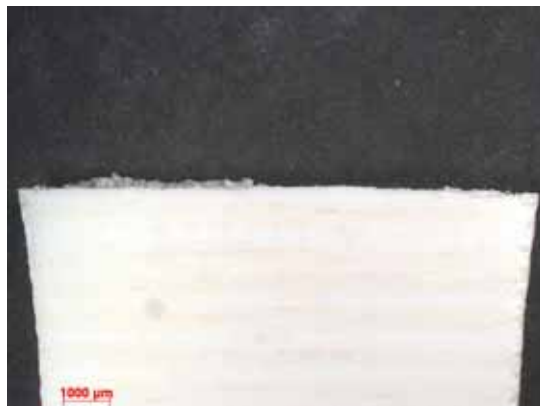
Figure B.25: Fracture surface of the N610/LaPO₄/Al₂O₃-LaPO₄ specimen with 10ply 0°/90° uni-tape lay-up subjected tension to failure in laboratory air at 1100 °C.

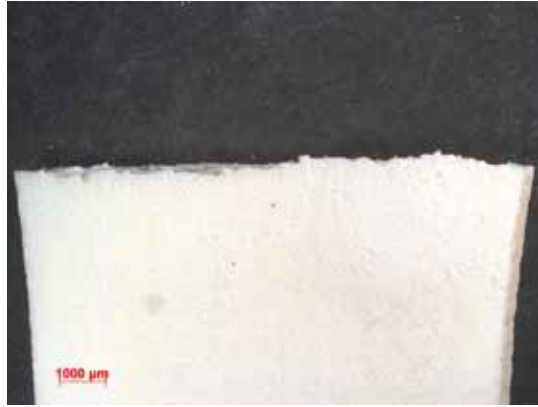
Figure B.26: Fracture surface of the N610/LaPO₄/Al₂O₃-LaPO₄ specimen with 10ply 0°/90° uni-tape lay-up subjected tension to failure in laboratory air at 1100 °C.

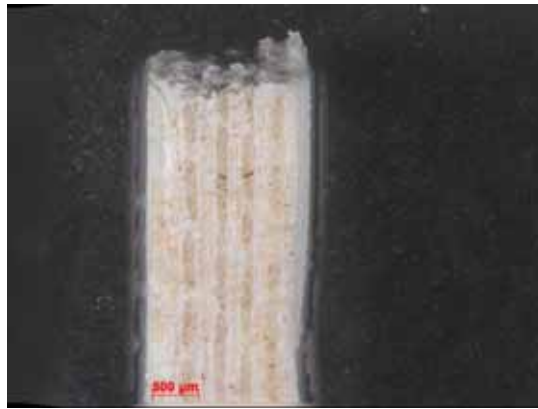
Figure B.27: Fracture surface of the N610/LaPO₄/Al₂O₃-LaPO₄ specimen with 10ply 0°/90° uni-tape lay-up subjected tension to failure in laboratory air at 1100 °C.

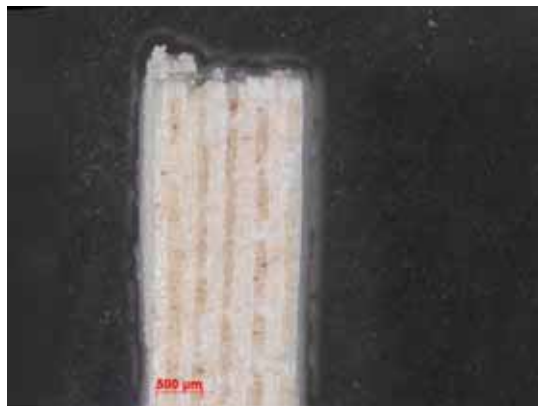
Figure B.28: Fracture surface of the N610/LaPO₄/Al₂O₃-LaPO₄ specimen with 10ply 0°/90° uni-tape lay-up subjected tension to failure in laboratory air at 1100 °C.

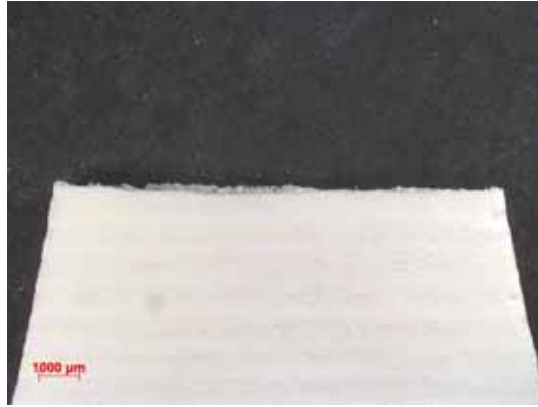
Figure B.29: Fracture surface of the N610/LaPO₄/Al₂O₃-LaPO₄ specimen with 10ply 0°/90° uni-tape lay-up subjected tension to failure in laboratory air at 1100 °C.

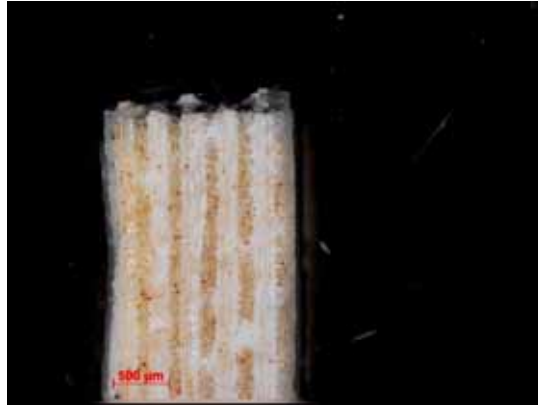
Figure B.35: Fracture surface of the N610/LaPO₄/Al₂O₃-LaPO₄ specimen with 10ply 0°/90° uni-tape lay-up subjected tension to failure in laboratory air at 1100 °C.

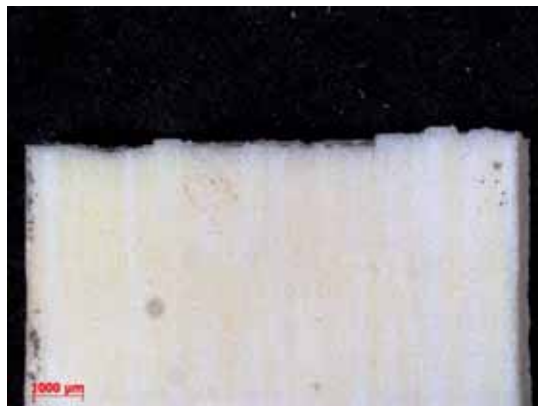
Figure B.37: Fracture surface of the N610/LaPO₄/Al₂O₃-LaPO₄ specimen with 10ply 0°/90° uni-tape lay-up subjected tension to failure in laboratory air at 1100 °C.

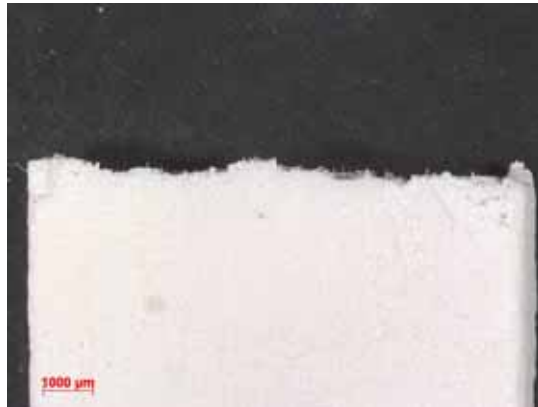
Figure B.39: Fracture surface of the N610/Al₂O₃-LaPO₄ specimen with 10ply 0°/90° uni-tape lay-up subjected to creep test at 25 MPa in steam at 1100 °C ($t_f = 40.1$ h).

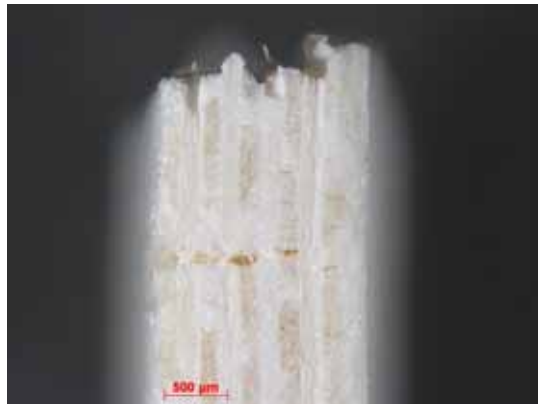
Figure B.40: Fracture surface of the N610/Al₂O₃-LaPO₄ specimen with 10ply 0°/90° uni-tape lay-up subjected to creep test at 25 MPa in steam at 1100 °C ($t_f = 40.1$ h).

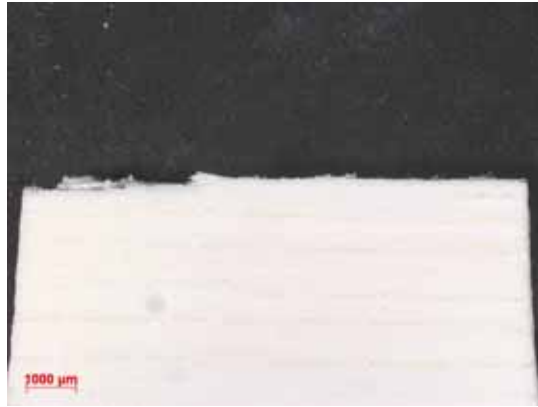
Figure B.41: Fracture surface of the N610/ Al_2O_3 - LaPO_4 specimen with 10ply $0^\circ/90^\circ$ uni-tape lay-up subjected to creep test at 25 MPa in steam at 1100 °C ($t_f = 40.1$ h).

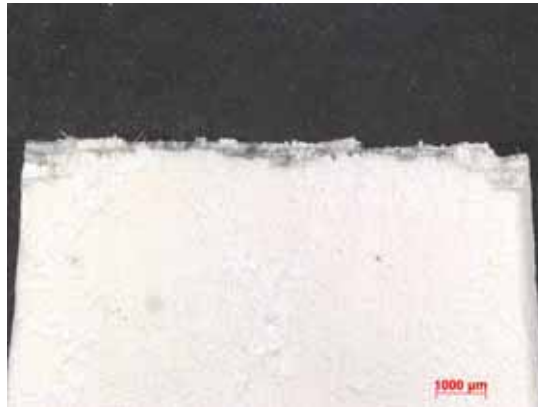
Figure B.42: Fracture surface of the N610/ Al_2O_3 - LaPO_4 specimen with 10ply $0^\circ/90^\circ$ uni-tape lay-up subjected to creep test at 25 MPa in steam at 1100 °C ($t_f = 40.1$ h).

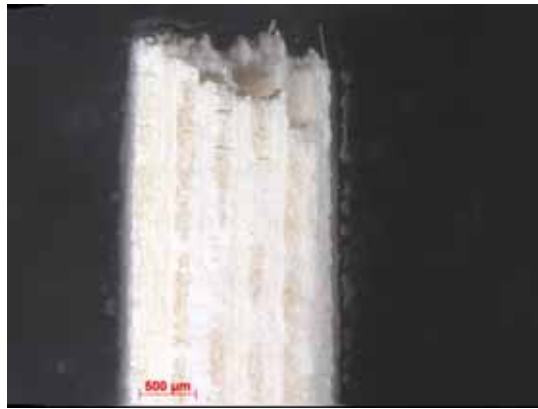
Figure B.44: Fracture surface of the N610/ Al_2O_3 - LaPO_4 specimen with 10ply $0^\circ/90^\circ$ uni-tape lay-up subjected to creep test at 25 MPa in steam at 1100 °C ($t_f = 40.1$ h).

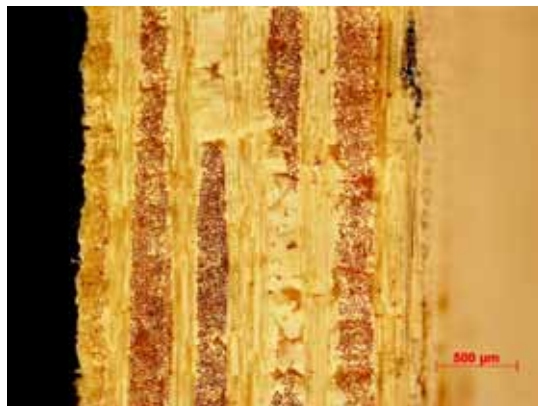
Figure B.45: Side view of the virgin N610/ LaPO_4 / Al_2O_3 specimen with 10ply $0^\circ/90^\circ$ uni-tape lay-up.

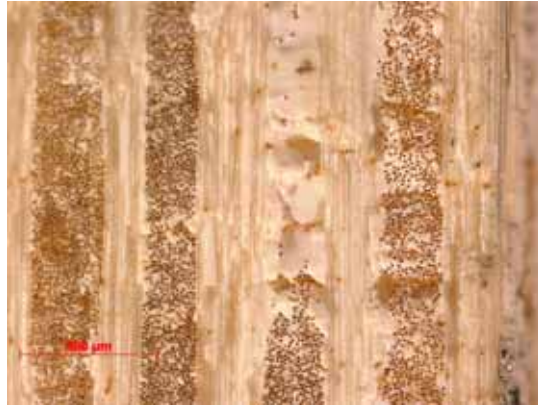
Figure B.46: Side view of the virgin N610/LaPO₄/Al₂O₃ specimen with 10ply 0°/90° uni-tape lay-up.

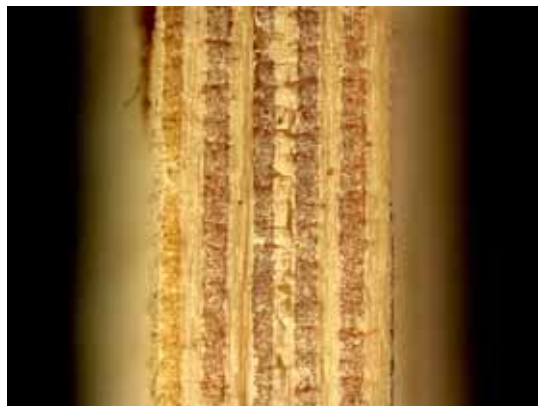
Figure B.48: Side view of the virgin N610/LaPO₄/Al₂O₃ specimen with 10ply 0°/90° uni-tape lay-up.

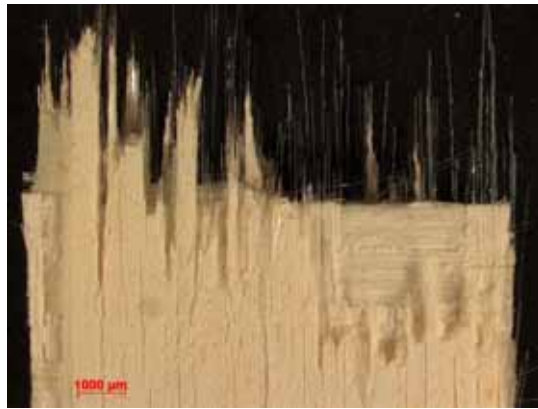
Figure B.51: Fracture surface of the N610/LaPO₄/Al₂O₃ specimen with 10ply 0°/90° uni-tape lay-up subjected tension to failure in laboratory air at 1100 °C.

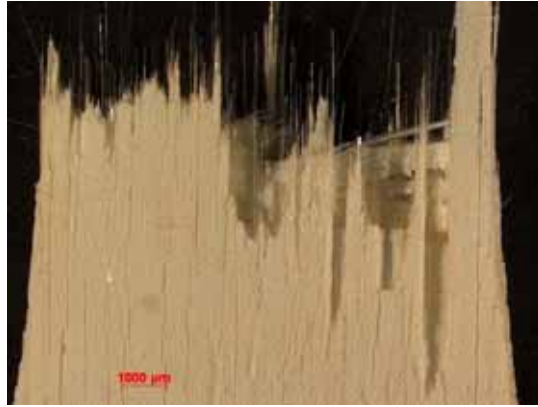
Figure B.53: Fracture surface of the N610/LaPO₄/Al₂O₃ specimen with 10ply 0°/90° uni-tape lay-up subjected tension to failure in laboratory air at 1100 °C.

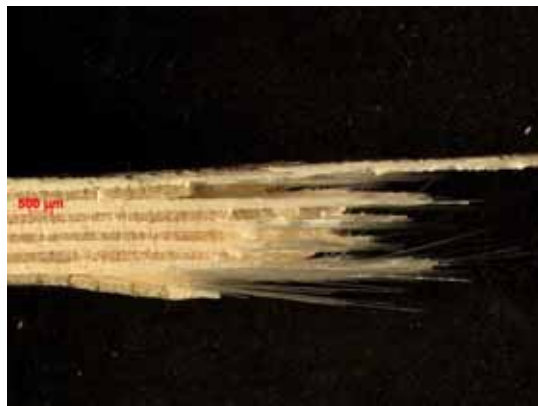
Figure B.55: Fracture surface of the N610/LaPO₄/Al₂O₃ specimen with 10ply 0°/90° uni-tape lay-up subjected tension to failure in laboratory air at 1100 °C.

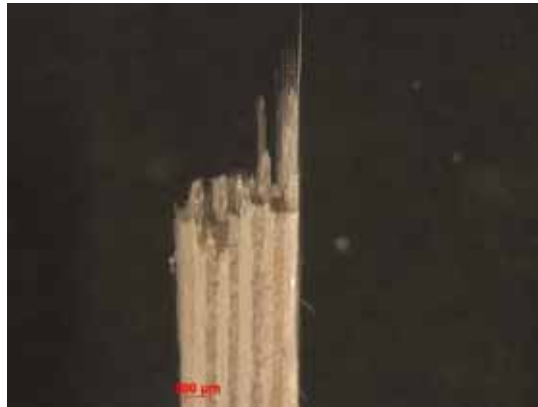
Figure B.60: Fracture surface of the N610/LaPO₄/Al₂O₃ specimen with 10ply 0°/90° uni-tape lay-up subjected to creep test at 85 MPa in air at 1100 °C ($t_f = 16.2$ h).

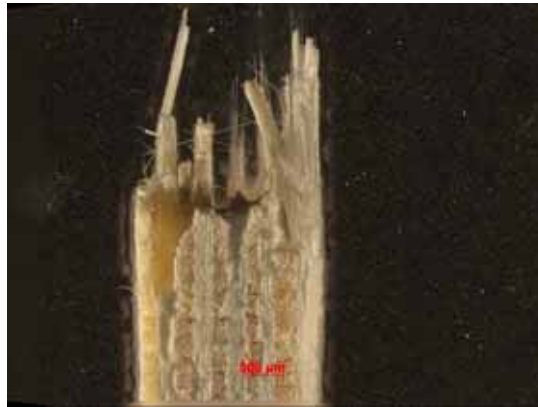
Figure B.67: Fracture surface of the N610/LaPO₄/Al₂O₃ specimen with 10ply 0°/90° uni-tape lay-up subjected to creep test at 85 MPa in steam at 1100 °C (t_f = 8.18 h).

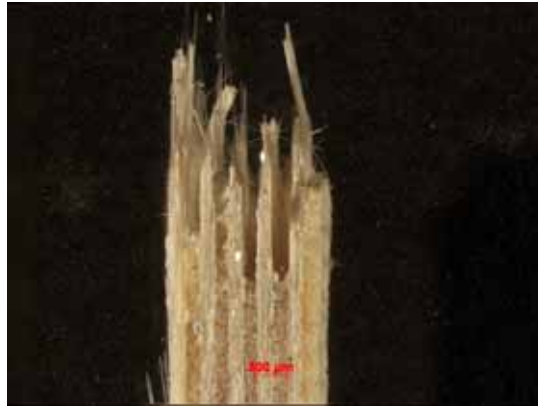
Figure B.68: Fracture surface of the N610/LaPO₄/Al₂O₃ specimen with 10ply 0°/90° uni-tape lay-up subjected to creep test at 85 MPa in steam at 1100 °C (t_f = 8.18 h).

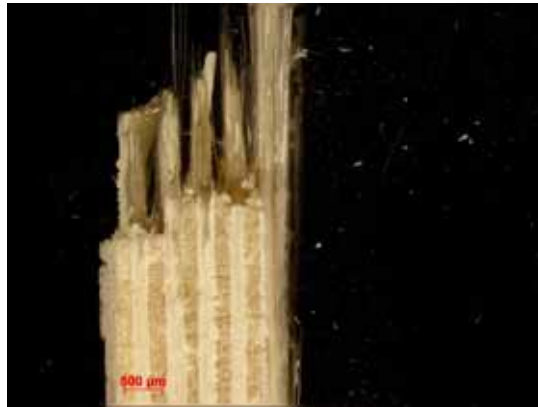
Figure B.73: Fracture surface of the N610/LaPO₄/Al₂O₃ specimen with 10ply 0°/90° uni-tape lay-up subjected to creep test at 110 MPa in steam at 1100 °C ($t_f = 0.35$ h).

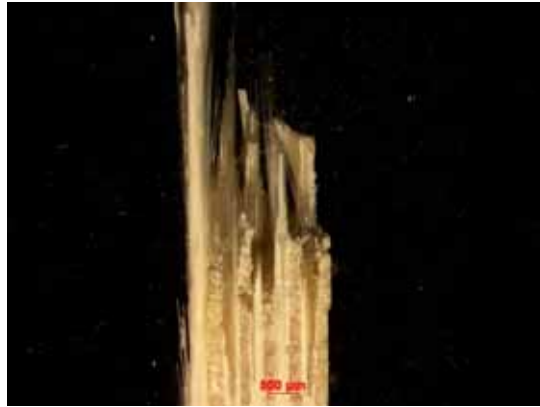
Figure B.74: Fracture surface of the N610/LaPO₄/Al₂O₃ specimen with 10ply 0°/90° uni-tape lay-up subjected to creep test at 110 MPa in steam at 1100 °C ($t_f = 0.35$ h).

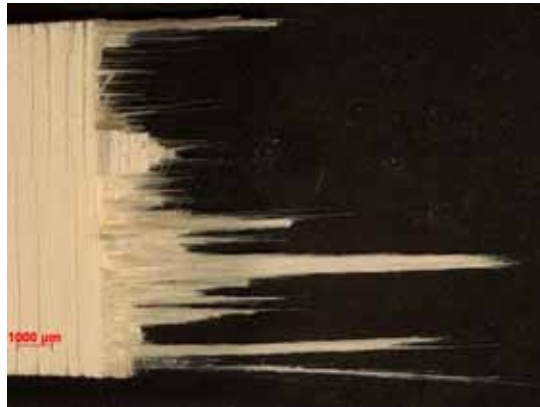
Figure B.75: Fracture surface of the N610/LaPO₄/Al₂O₃ specimen with 10ply 0°/90° uni-tape lay-up subjected to creep test at 110 MPa in steam at 1100 °C ($t_f = 0.35$ h).

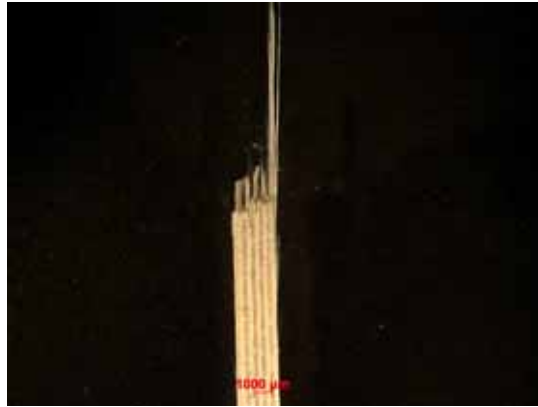
Figure B.76: Fracture surface of the N610/LaPO₄/Al₂O₃ specimen with 10ply 0°/90° uni-tape lay-up subjected to creep test at 110 MPa in steam at 1100 °C ($t_f = 0.35$ h).

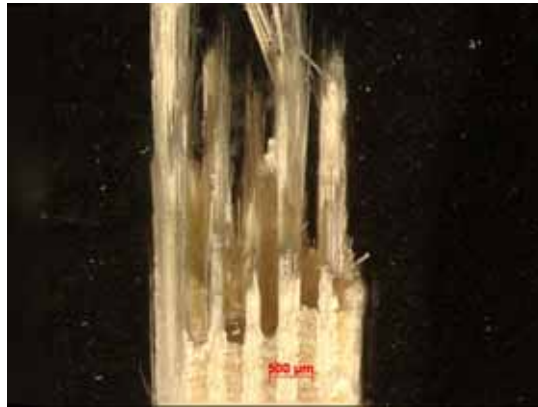
Figure B.81: Fracture surface of the N610/LaPO₄/Al₂O₃ specimen with 10ply 0°/90° uni-tape lay-up subjected to creep test at 110 MPa in steam at 1100 °C ($t_f = 0.35$ h).

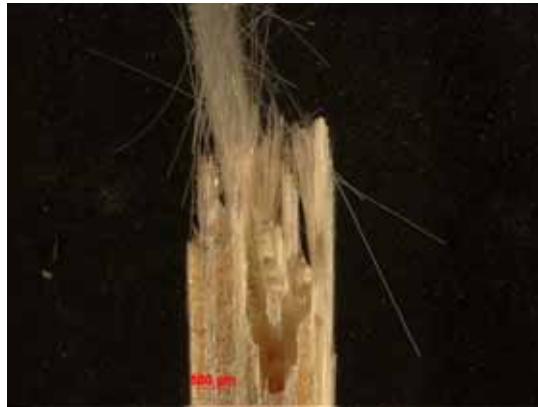
Figure B.83: Fracture surface of the N610/LaPO₄/Al₂O₃ specimen with 10ply 0°/90° uni-tape lay-up subjected to creep test at 120 MPa in air at 1100 °C ($t_f = 0.74$ h).

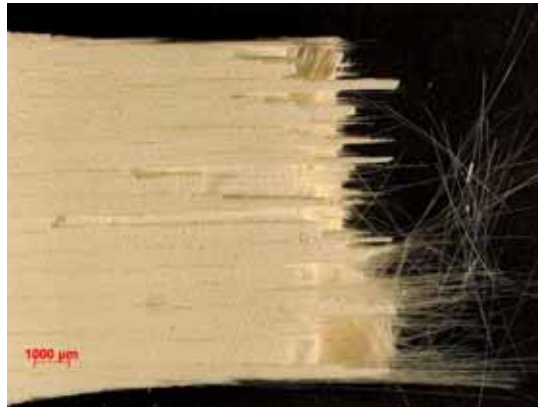
Figure B.85: Fracture surface of the N610/LaPO₄/Al₂O₃ specimen with 10ply 0°/90° uni-tape lay-up subjected to creep test at 120 MPa in air at 1100 °C ($t_f = 0.74$ h).

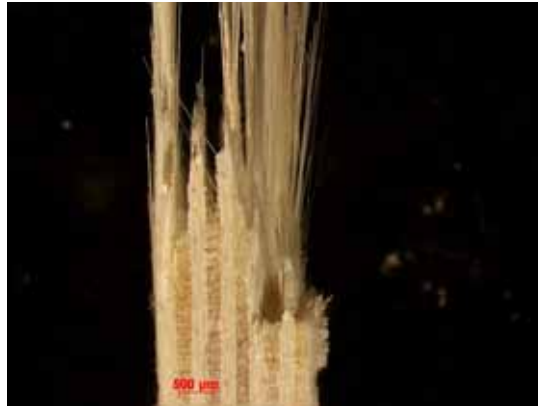
Figure B.88: Fracture surface of the N610/LaPO₄/Al₂O₃ specimen with 10ply 0°/90° uni-tape lay-up subjected to creep test at 120 MPa in air at 1100 °C ($t_f = 0.74$ h).
